HAMILTON ROAD SECTION

PACIFIC POWER

DEL NORTE TO YUROC
TRANSMISSION LINE

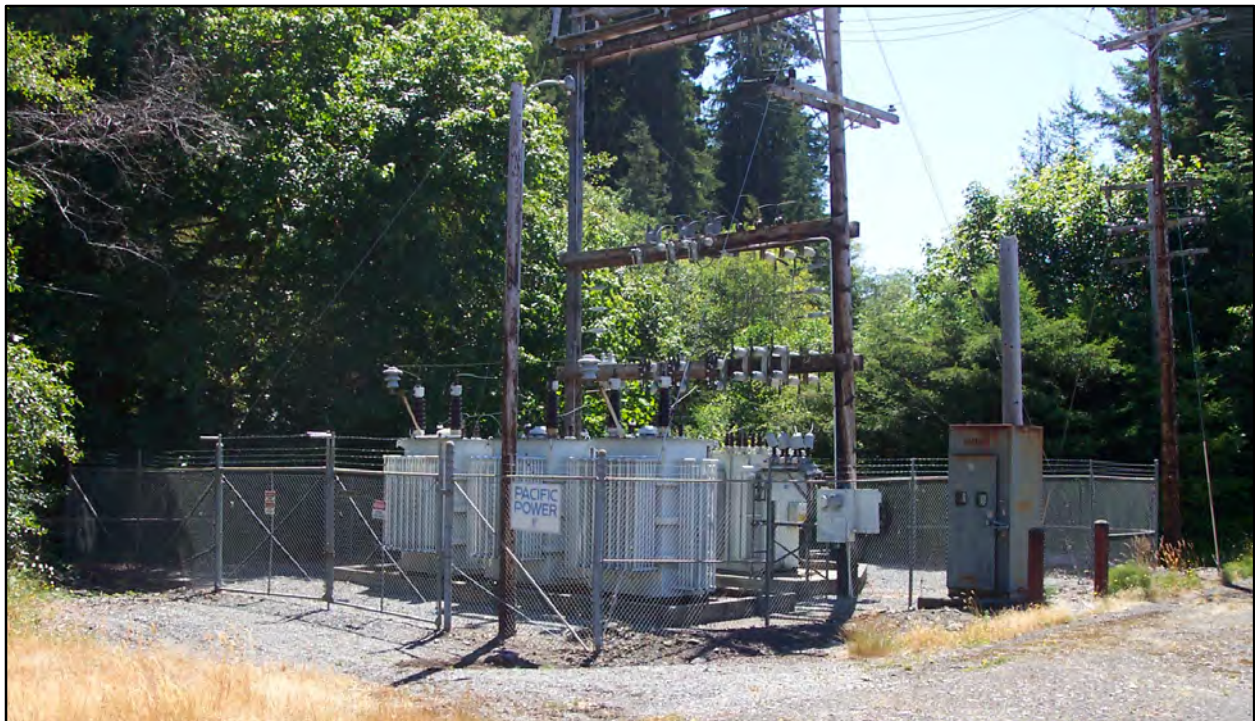
Photograph 4: Pole 1/18. PacifiCorp substation provides all the power to the Mill Creek restoration site in the State Park.

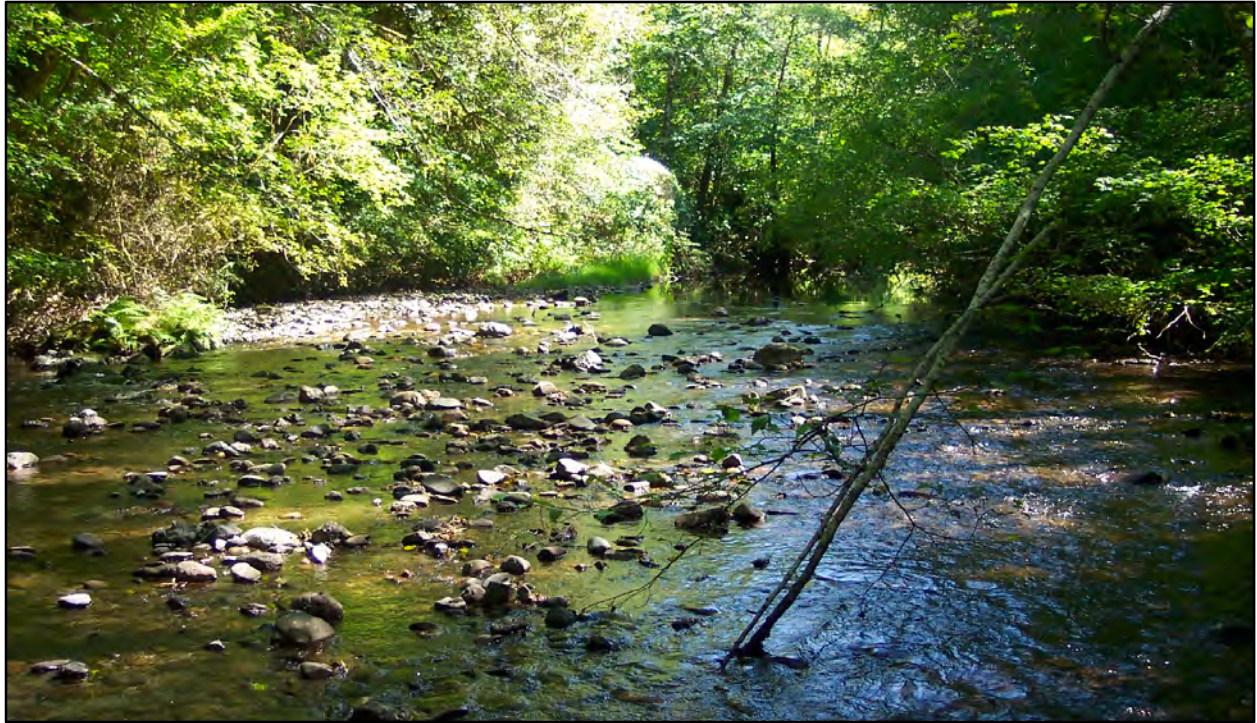
Photograph 5: Mill Creek at the bridge.

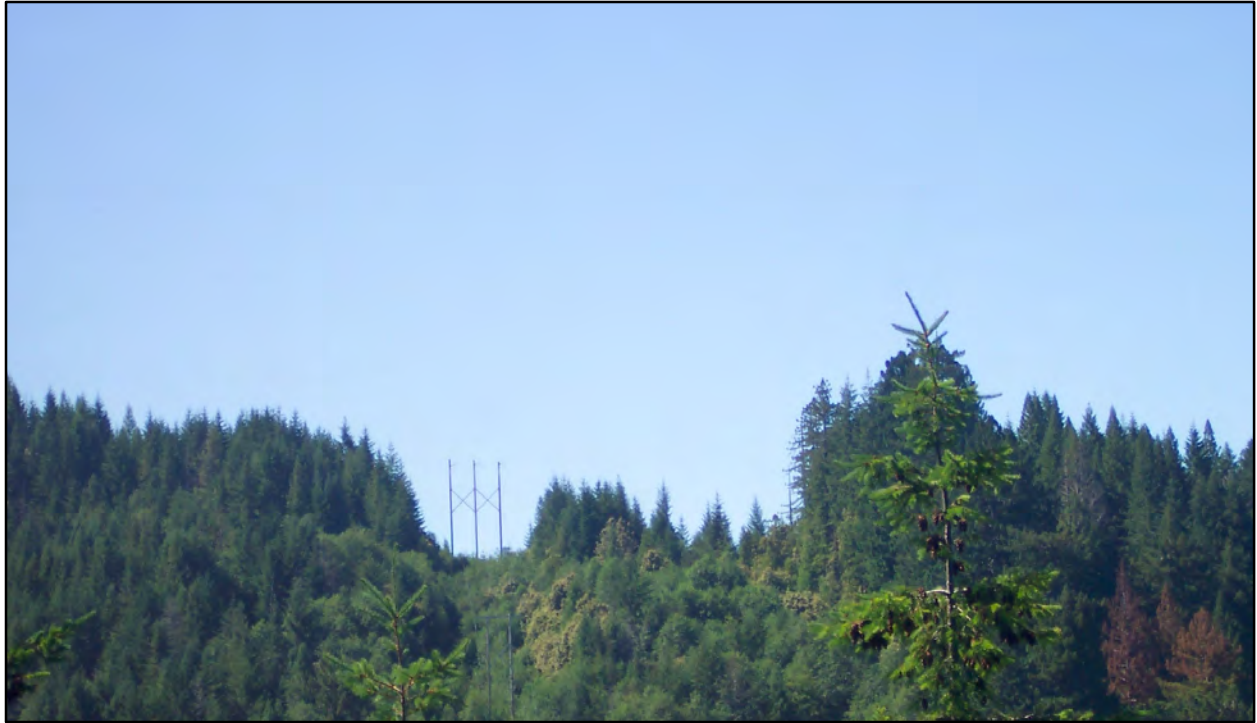
Photograph 12: Looking south from pole 2/17. To the left is second growth timber, adjacent to the power line right-of-way. On the far right are old growth redwoods, unaffected by power line activities.

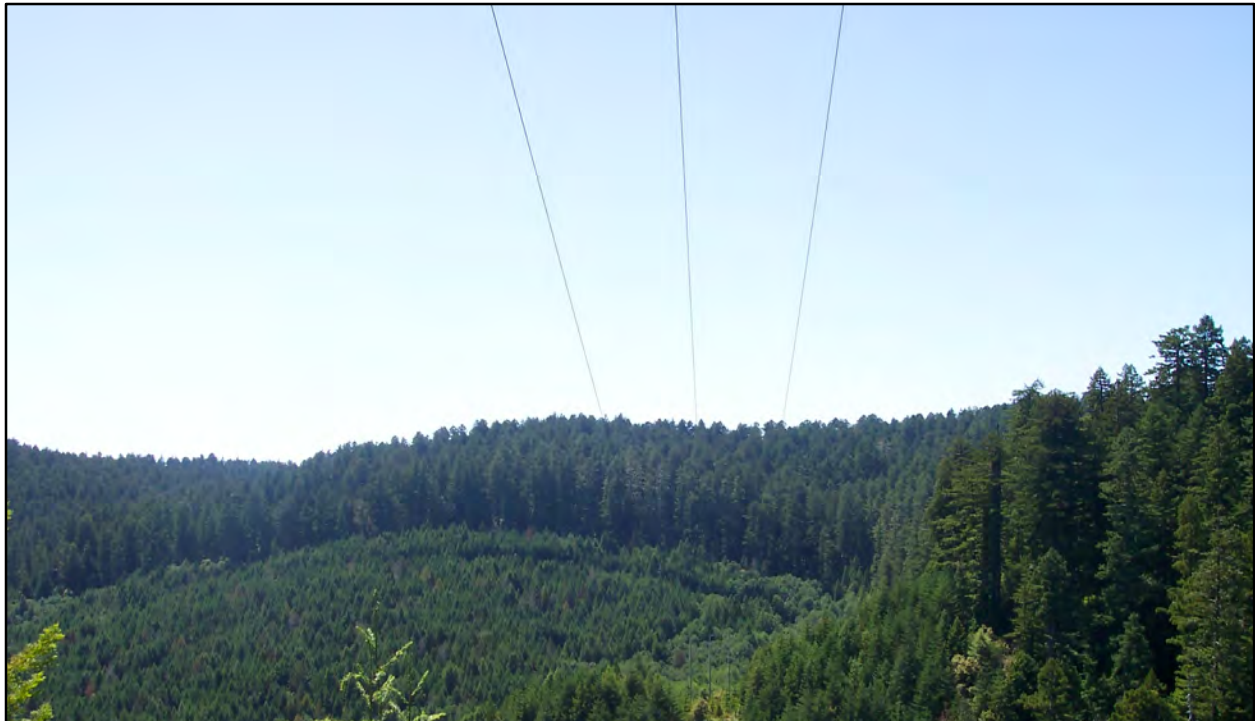
Photographs 17: Pole 2/20. Power line leaving Del Norte State Park. Note clear cut area on private lands in foreground.
